B Chen Architect PLLC

Re: 82-88 Fulton Street
New York, NY
Block: 77 Lot: 24

As per your request, an exterior survey of 82 Fulton Street was conducted on July 28, 2020 at approximately 2:00 pm in the afternoon. The survey consisted of walking around the public area of the two story, retail space, which was open to the public only. No survey of any interior retail space was conducted as per your instruction.

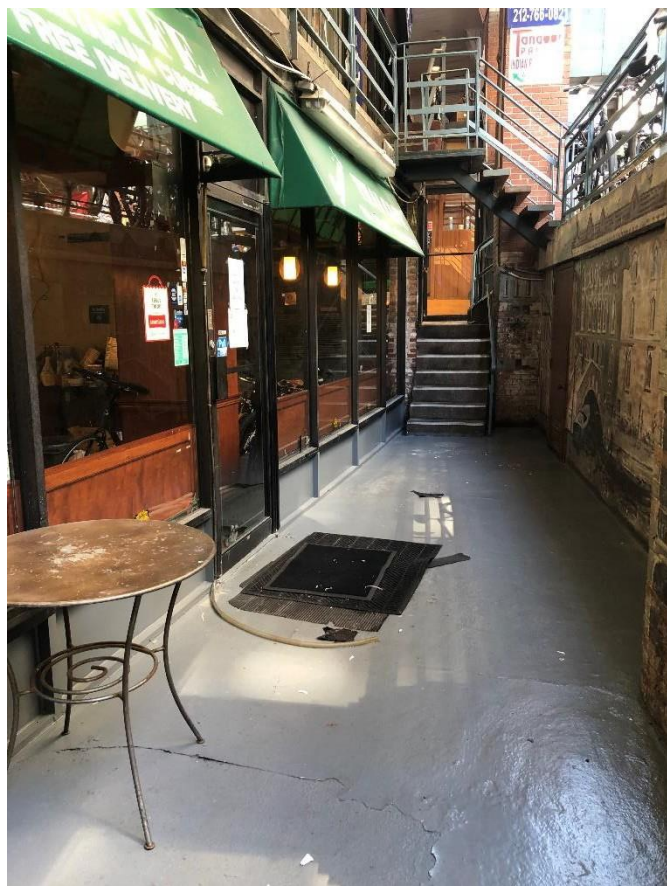
Figure 1-looking at exterior stair

survey might not be able to resolve. There is Turkish Spa, that has its' own entry way on the street wall and a stair leading down to an interior vestibule.

In looking at the layout of the existing retail space, a ramp solution would not be feasible, since there would not be enough room and clearance to make a handicap ramp work, especially with having to work with five different levels. The best case solution would be to create two different sets of handicap accessible lifts. One for the left side of the building and one for the right side of the building along Fulton Street. The lift could be installed within the building's envelope, taking over some retail space. The amount of space required would be dependent on how the lift is design and oriented. The only drawback with the lift solution is for the Spa. Without conducting an interior survey, there is no way to tell if the lift will be able to provide access to the rest of the Spa space. Although designated as a landmark by New York City, it is not listed as such on the National Registry and this place of public accommodation must still be in compliance with the Americans With Disabilities Act. As such, approval for plans for ADA compliance is only required from New York City. As a practical matter, the burden is on the facility owner, tenant or manager to prove the threat to the historic facility. It is a narrowly interpreted exception to the global requirements of the ADA and would necessitate drawings

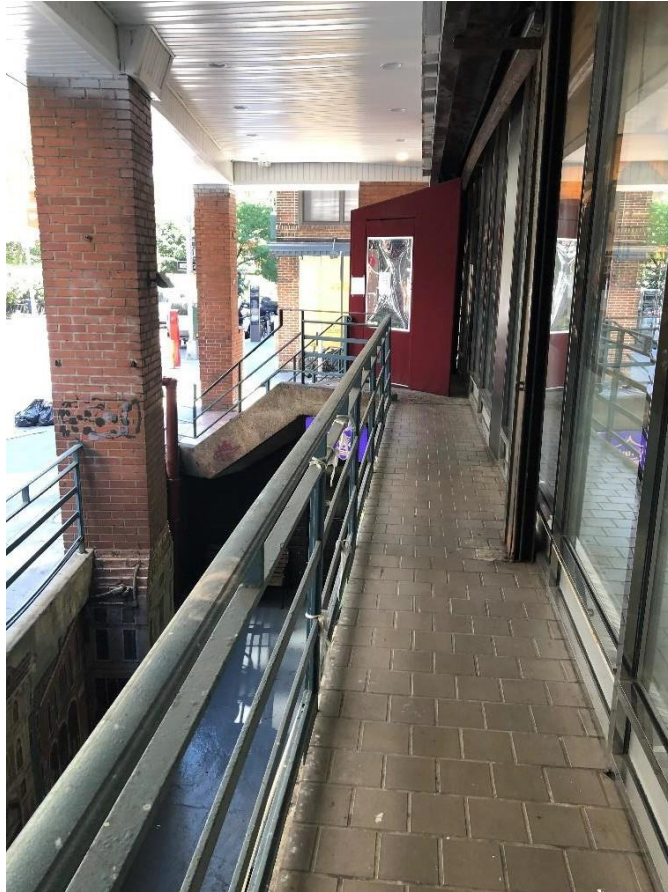
The building is a mixed-use residential and commercial building, located on the corner of Gold Street and Fulton Street. The retail space consisted of two story starting from the cellar level, being setback from the street wall with an open walkway in front of the retail space, similar to a two story, strip mall design or open arcade. The floor to ceiling height of the cellar level is approximately 11'-0" high with a small open courtyard in the front, and between 6'-0" to 7'-8" below sidewalk grade level. The retail space is what we consider a split level situation. Along Fulton street, the retail space also has another split level situation. This creates a situation where there is actually four different level of retail space with the sidewalk being a fifth level. Along Fulton Street, there is also another issue which an exterior

Figure 2-looking at walkway in front of retail space
